February 1945 as
Advance Restricted Report E5B07

EFFECT OF PROGRESSIVE RING FAILURE ON PISTON DESTRUCTION

By Max J. Tauschek and Lester C. Corrington

Aircraft Engine Research Laboratory
Cleveland, Ohio

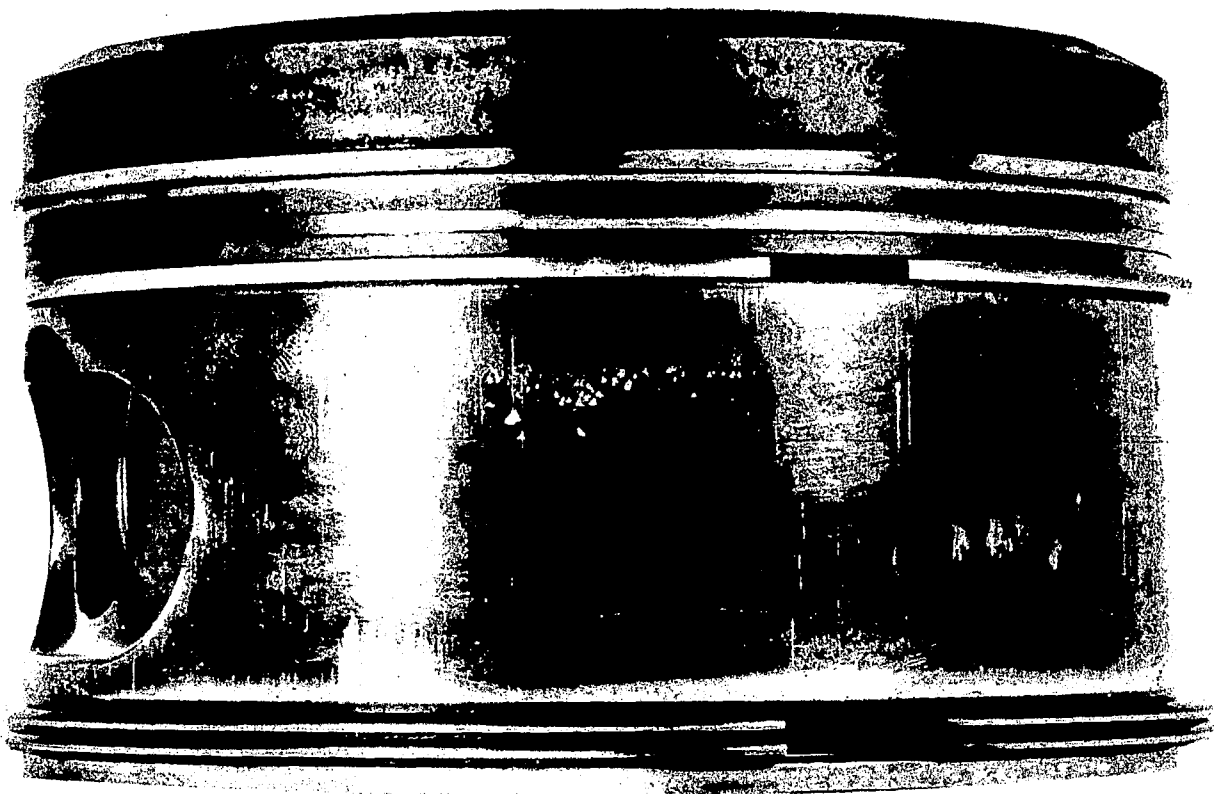
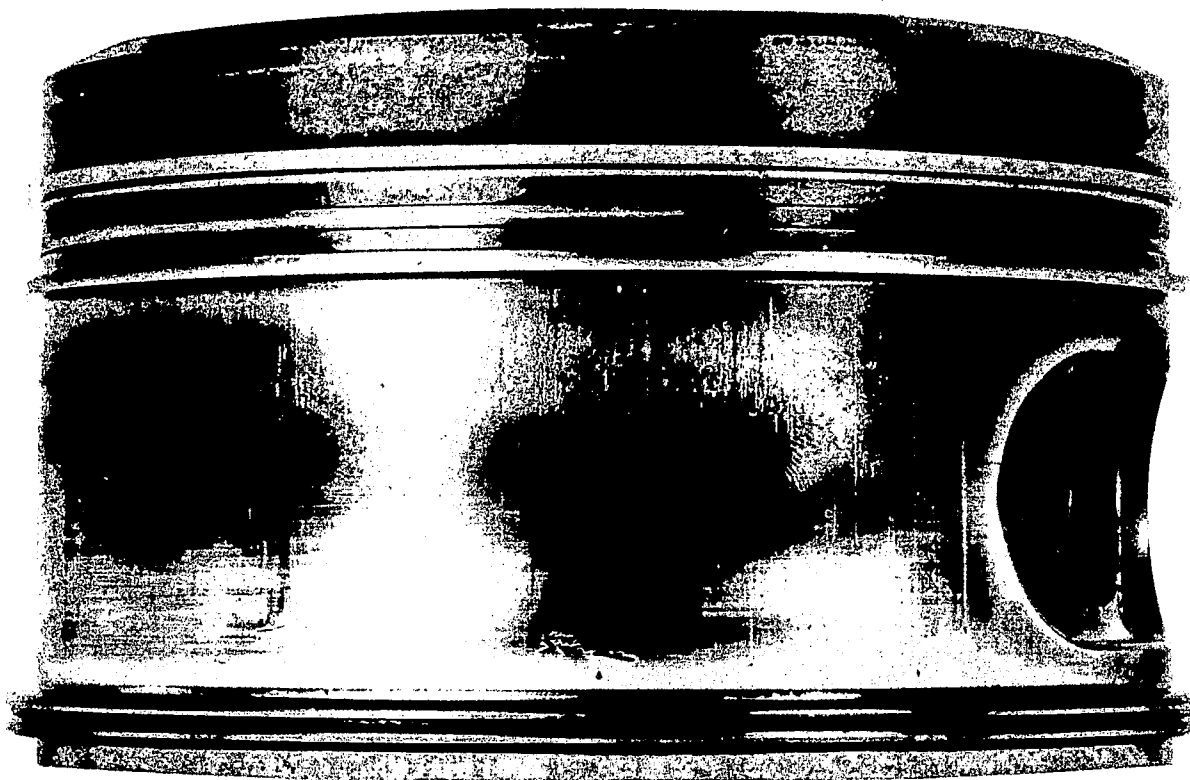
NACA
C-2846

The piston used in the first test had previously been used to obtain preignition data in connection with another project. These tests comprised about 15 hours running time. The severe operating conditions encountered in the preignition tests resulted in breaking of the top ring and sticking of the second ring. Figure 1 shows the piston prior to installation in the cylinder at the beginning of the endurance test. A clean used piston equipped with new piston rings was used for the second test.

Figure 1. - Piston and ring assembly just before the first endurance test. Failure of top and second rings has taken place.

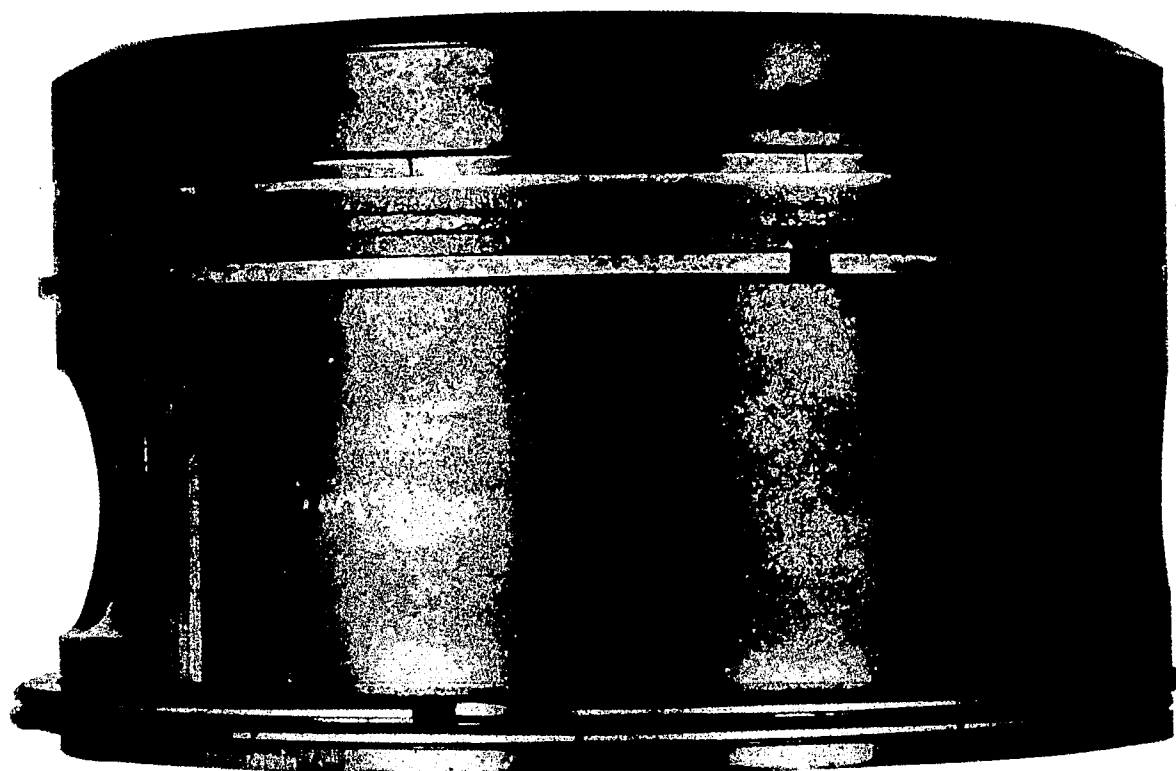
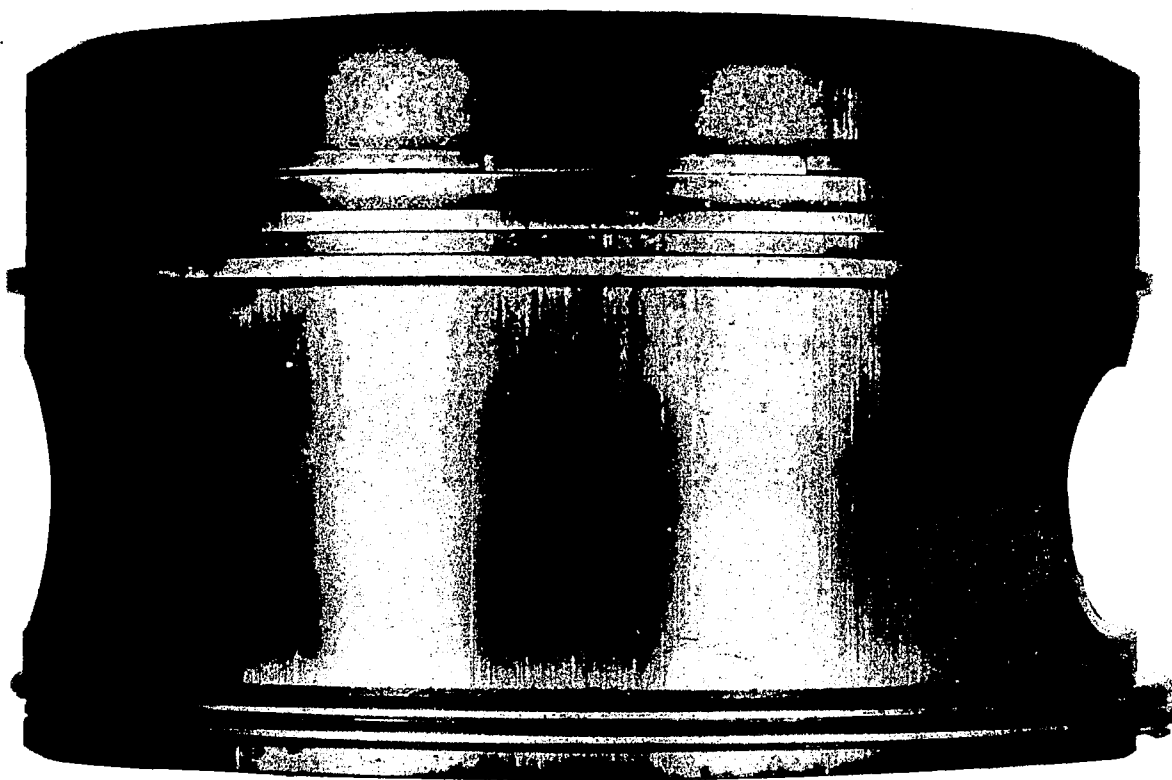
NACA
C-2848

At the end of 7.5 hours the piston was removed for inspection. By this time complete failure of the compression rings had taken place but the oil rings were still in reasonably good condition (fig. 2). The piston and ring assembly was reinstalled and the test continued. After an additional 10.6 hours, the inlet-air pressure was increased to determine the power level at which immediate and complete piston failure would take place. This failure occurred at an inlet-air pressure of 68 inches of mercury absolute with the results shown in figure 3. The total test time was 33.1 hours including the preignition tests conducted previous to the endurance run.

time of the inspection when all the compression rings had failed (fig. 2), which suggests that the oil-control rings had a considerable effect in sealing the combustion chamber.

Figure 2. - Piston and ring assembly after 7.5 hours of first endurance test. All compression rings have failed.

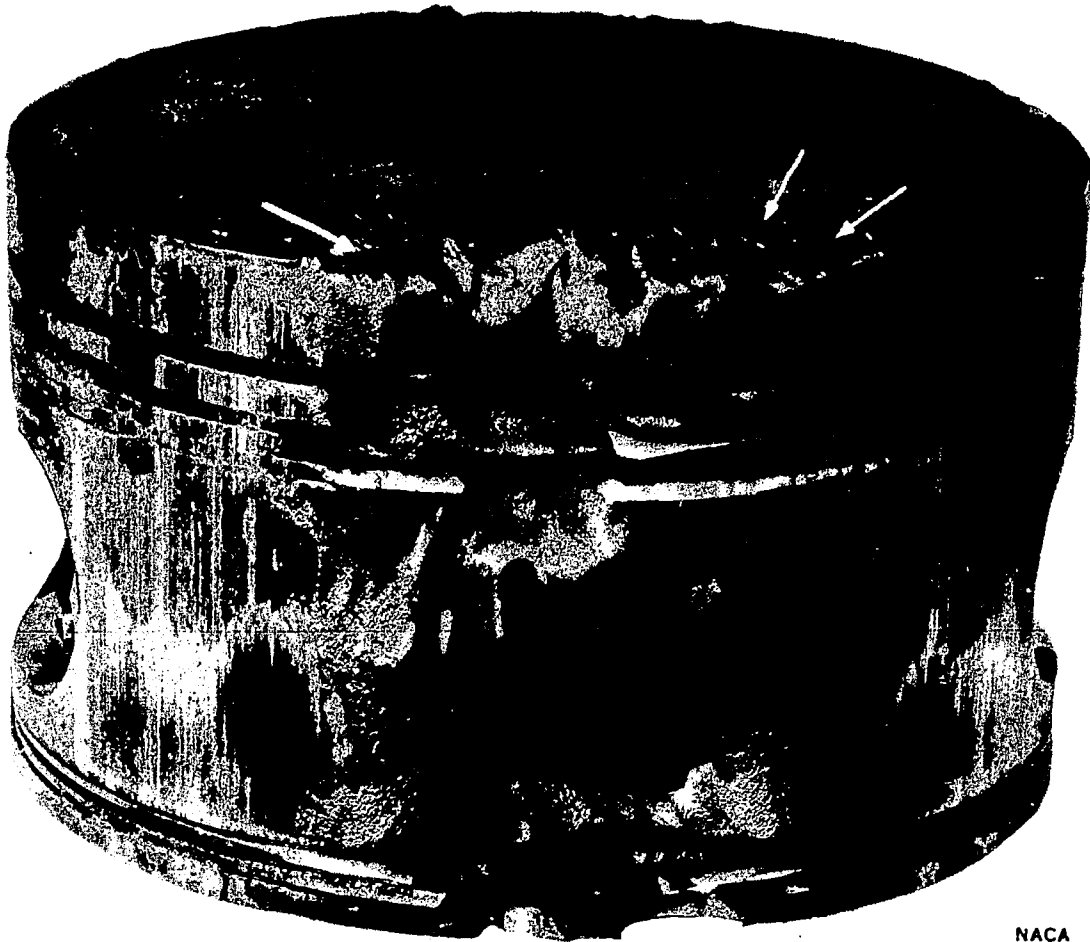
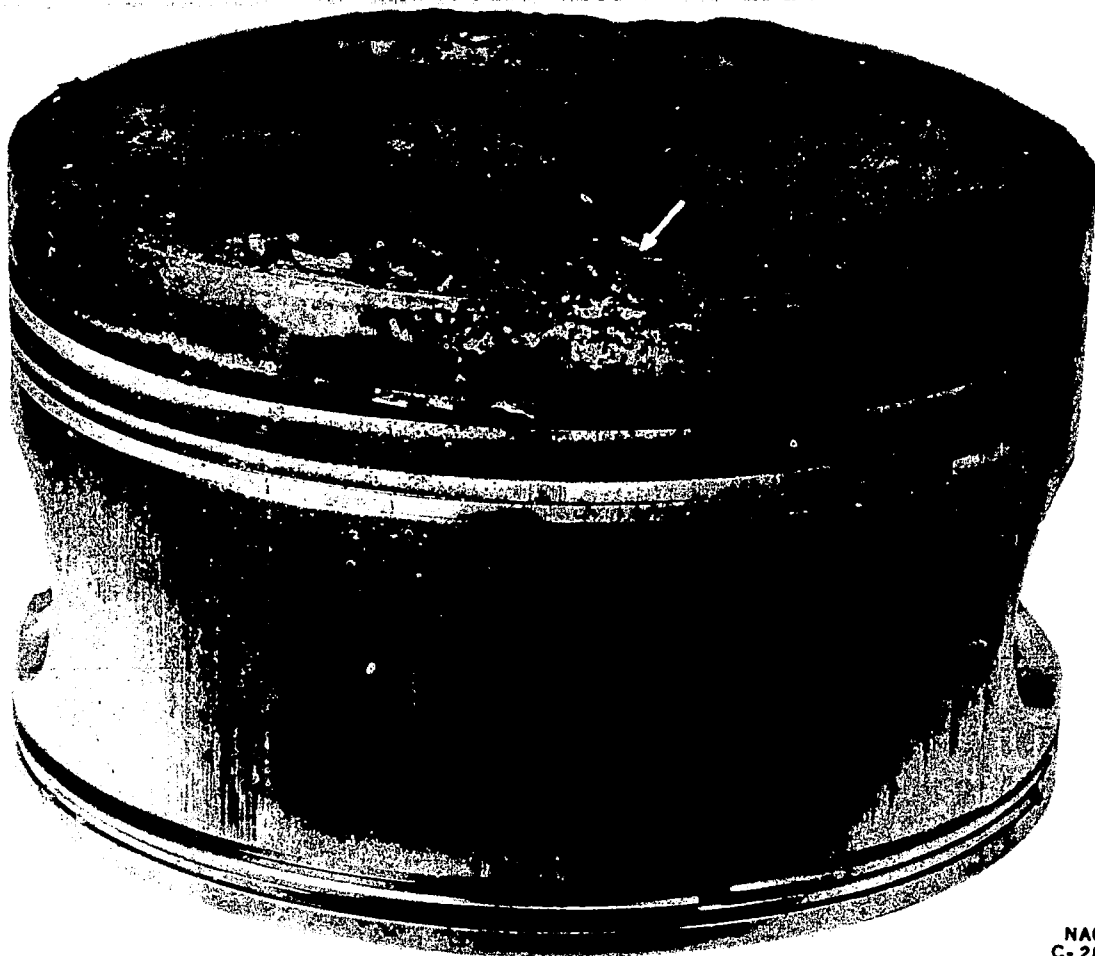
NACA
C-2858

Analysis of failed piston. - Figure 3 shows the piston and ring assembly after the final failure of the first test. A wide deep channel has been burned down the entire length of the piston and a hole has been made through the piston skirt above the oil rings. This damage was confined to the minor thrust face of the piston; the major thrust face remained comparatively unharmed.

The ultimate failure was most likely caused by the action of high-temperature gases against the side of the piston, probably taking place over a relatively long period of time. Figure 7 shows the ring belt of a piston that had been operated under severe conditions in another test program. The large flow of high-temperature gases resulting from compression-ring failure has begun an erosion of one of the ring lands, which probably would have resulted in a large channel similar to figure 3 if operation had been continued long enough. These high-temperature gases are not necessarily all blow-by gases. A portion of these gases leaks by all the rings as blow-by gases, whereas part of them travel down and back up past the ineffective rings as the pressure in the combustion chamber is alternately increased and decreased. The net result is a scouring action, which in all probability causes the erosion shown in figures 3 and 7.

Further evidence that this channeling took place over a prolonged period of time is found in the fact that the entire top ring and parts of the second ring are missing from the piston in figure 3. The channel in the face of the piston provides the only escape path for these ring pieces. Because the broken rings were partly stuck in the grooves, the time required for them to work their way along the grooves to the channel would probably be quite appreciable. The pieces of rings imbedded in the top of the piston at the end of the test (shown by arrows in fig. 3) were covered with a coating of carbon, indicating their presence on the top of the piston for a considerable length of time. The preignition in the engine previously mentioned may have been caused by these ring pieces in the combustion chamber or by the ends of the compression rings left exposed by the formation of the channel down the side of the piston. The fact that particles of aluminum alloy were found lodged in the oil-ring groove, displaced as much as 90° from the channel in the face of the piston, lends further support to the supposition that the channeling of the piston took place over an extended period of time.

The final destruction of the piston occurred without any forewarning other than the high blow-by rates and did not extend beyond a few engine cycles. The piston skirt had been weakened by the channeling and by the increased temperature and the full pressure of the combustion chamber was acting on the sides of the channel.

The stresses in the aluminum became so great and the temperature so high that the skirt collapsed and permitted the free flow of burning gases into the crankcase.

Figure 3. - Piston and ring assembly at end of first endurance test. Total test time 33.1 hours. Arrows indicate pieces of piston rings imbedded in piston.

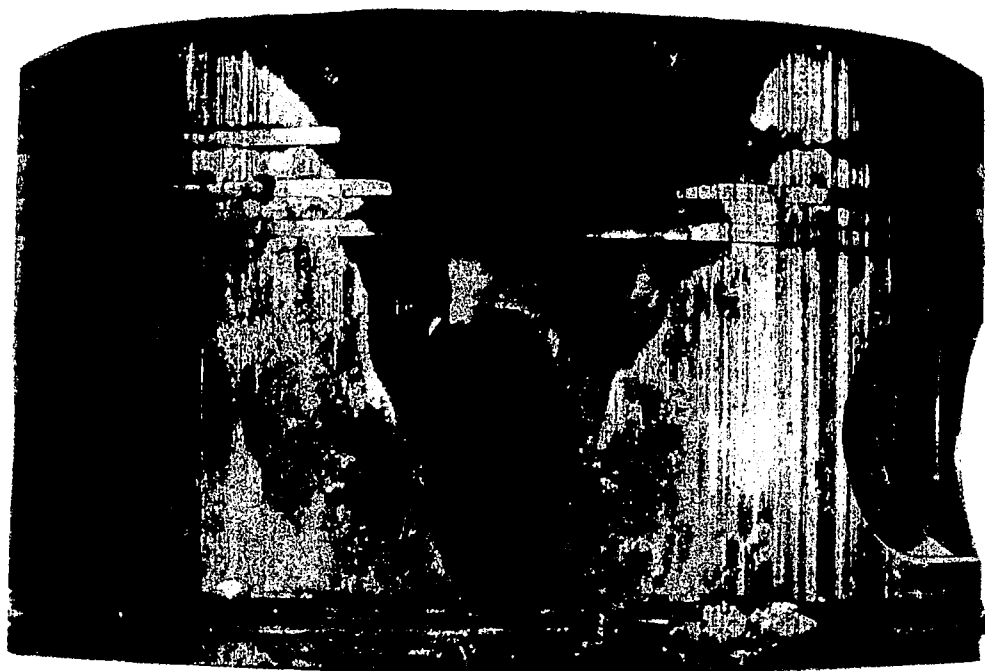
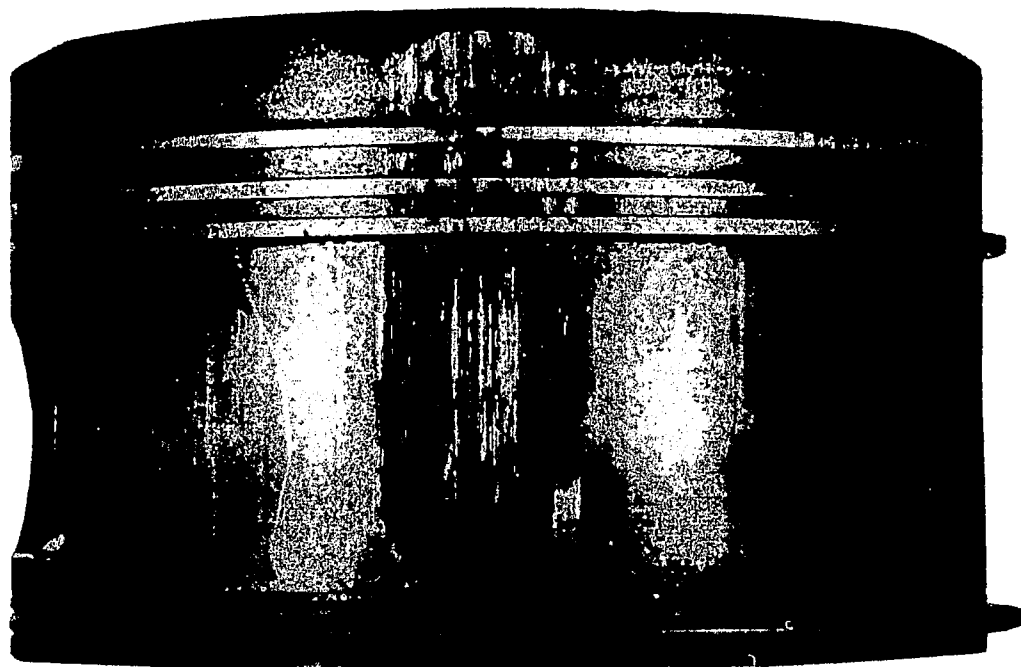
NACA
C-3441

Analysis of failed piston. - Figure 9 shows the piston at the end of the second test. The failure was quite similar to that of the first test. In this case, however, much of the top two compression rings was still in the ring grooves, probably caused by the rings' being more severely stuck than in the first test and therefore not so free to rotate in the grooves.

Particles of aluminum alloy were found in the oil-ring groove displaced a considerable distance from the point of failure. Here again is evidence that the channeling of the piston took place over an appreciable period of time. It appears unlikely that these aluminum particles could have moved so far along the groove at the instant of final failure.

Figure 9. - Piston and ring assembly at end of second endurance test. Total test time, 84.25 hours.
